# HISTORICALLY SIGNIFICANT ARCHITECTURE IN AMES

DEPARTMENT OF  
COMMUNITY DEVELOPMENT  
CITY OF AMES

This book is a compilation and summary of data gathered by the Central Iowa Regional Association of Local Governments (CIRALG) in conjunction with the Iowa Division of Historic Preservation.

It contains the results of a survey conducted in 1979 of architecturally significant buildings in Ames. Similar surveys were conducted throughout the eight county CIRALG area, with 125 communities being canvassed.

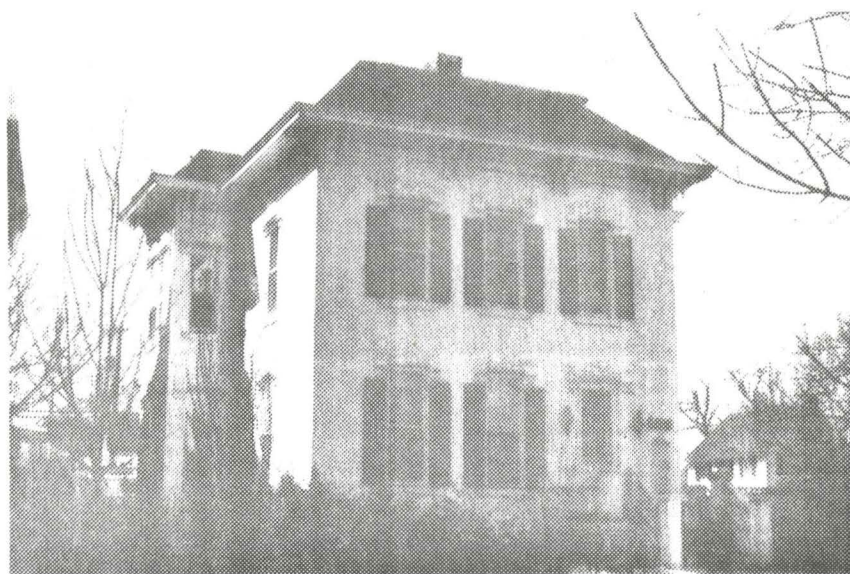
**THREATS TO STRUCTURE:** eave around West addition is rusting badly

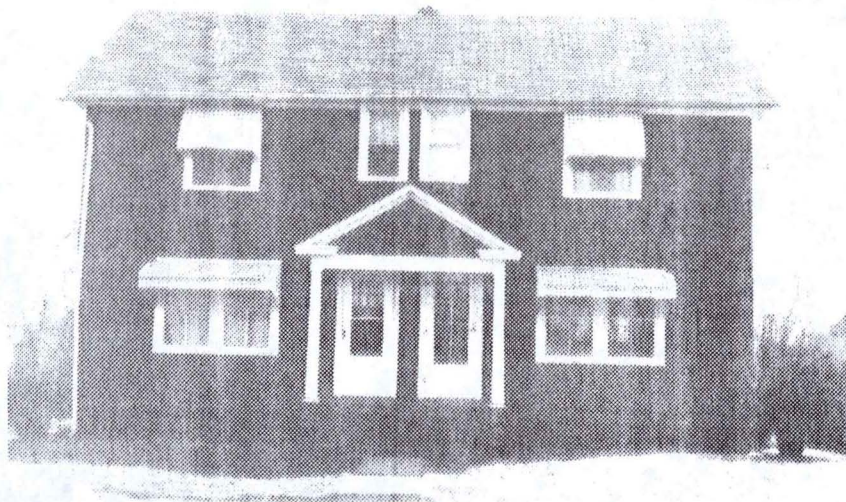
**STREET ADDRESS:** 616 - 618 Burnett Avenue  
**ORIGINAL USE:** Residence  
**PRESENT USE:** Residence - Duplex

**THREATS TO STRUCTURE:** eave lines could use some repair framing.

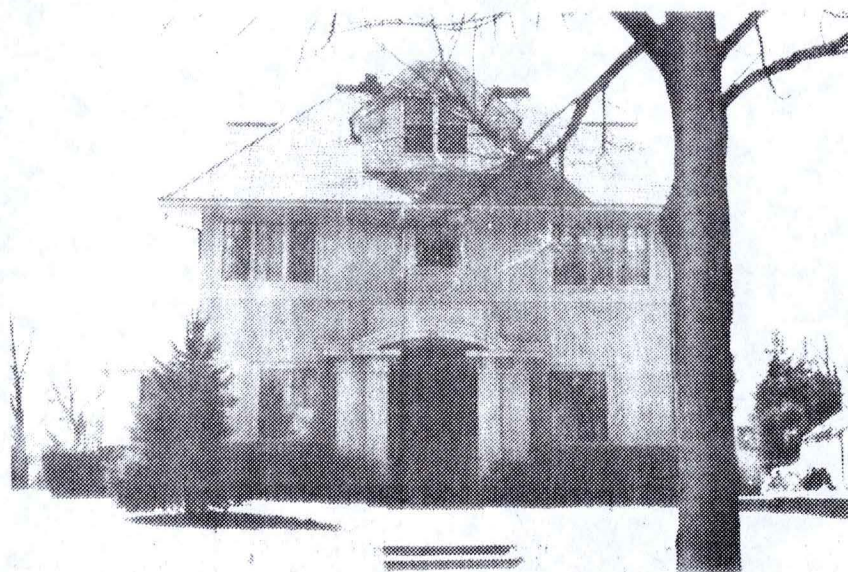
**THREATS TO STRUCTURE:** slight rusting on eave
